RATTLESNAKE CREEK DAM REMOVAL MONITORING

2021 REPORT

PREPARED BY TROUT UNLIMITED, WATERSHED EDUCATION NETWORK AND
MONTANA FISH, WILDLIFE & PARKS FISHERIES DIVISION
WITH SUPPORT FROM THE RESOURCES LEGACY FUND

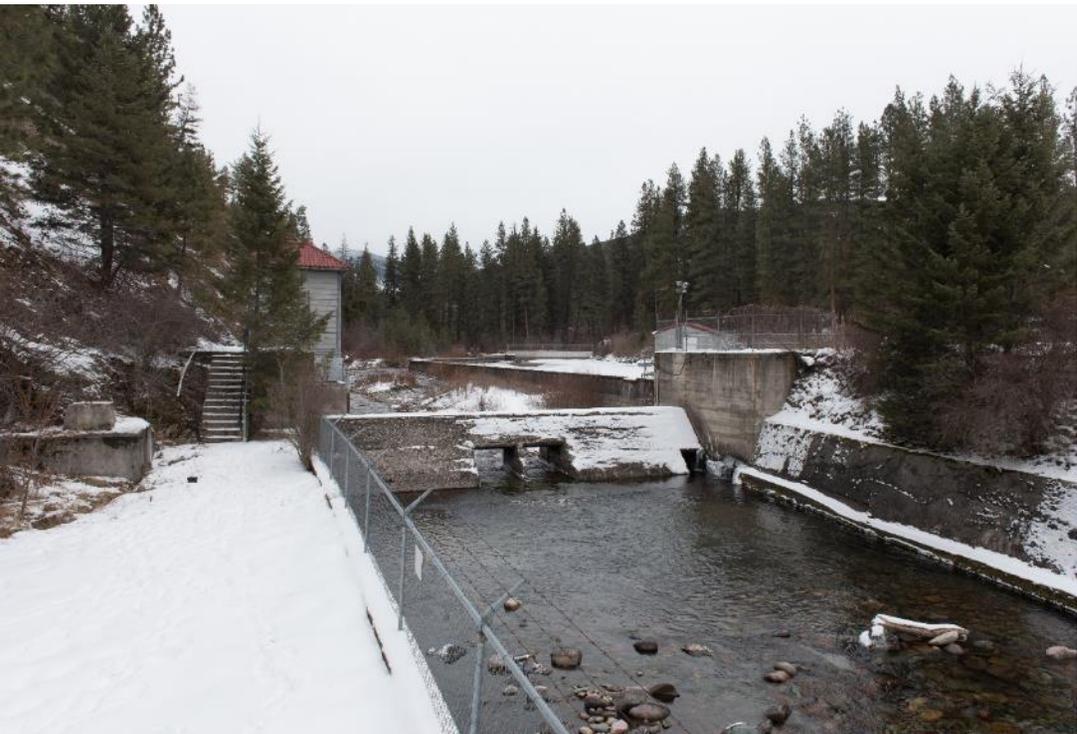
Dam site looking northeast (upstream) from right bank

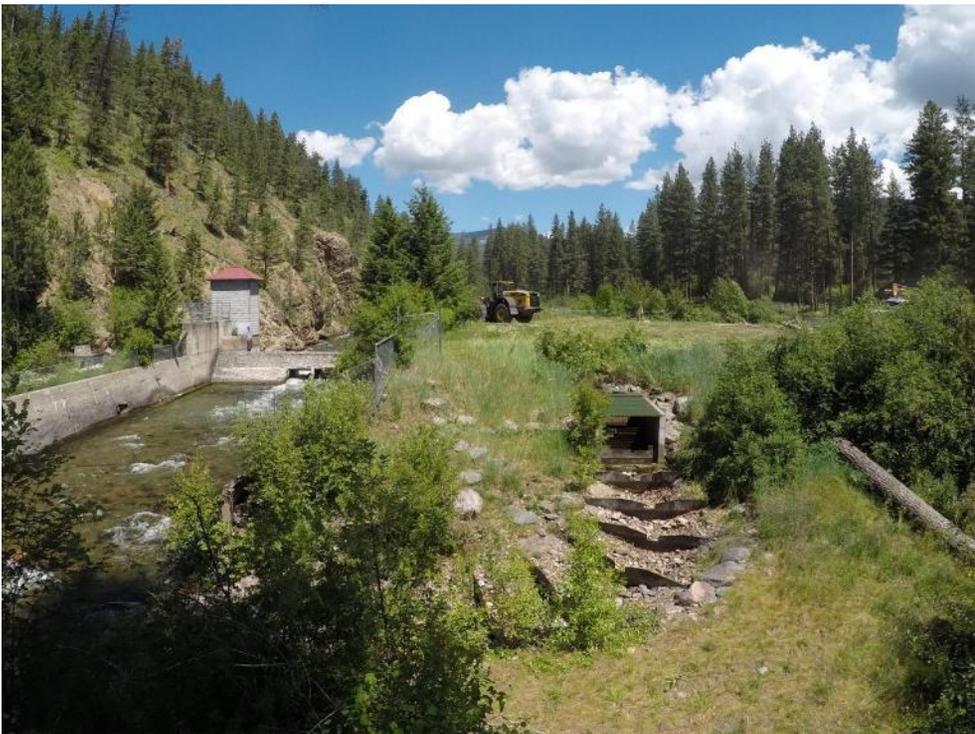
Former fish ladder and dam viewed from downstream

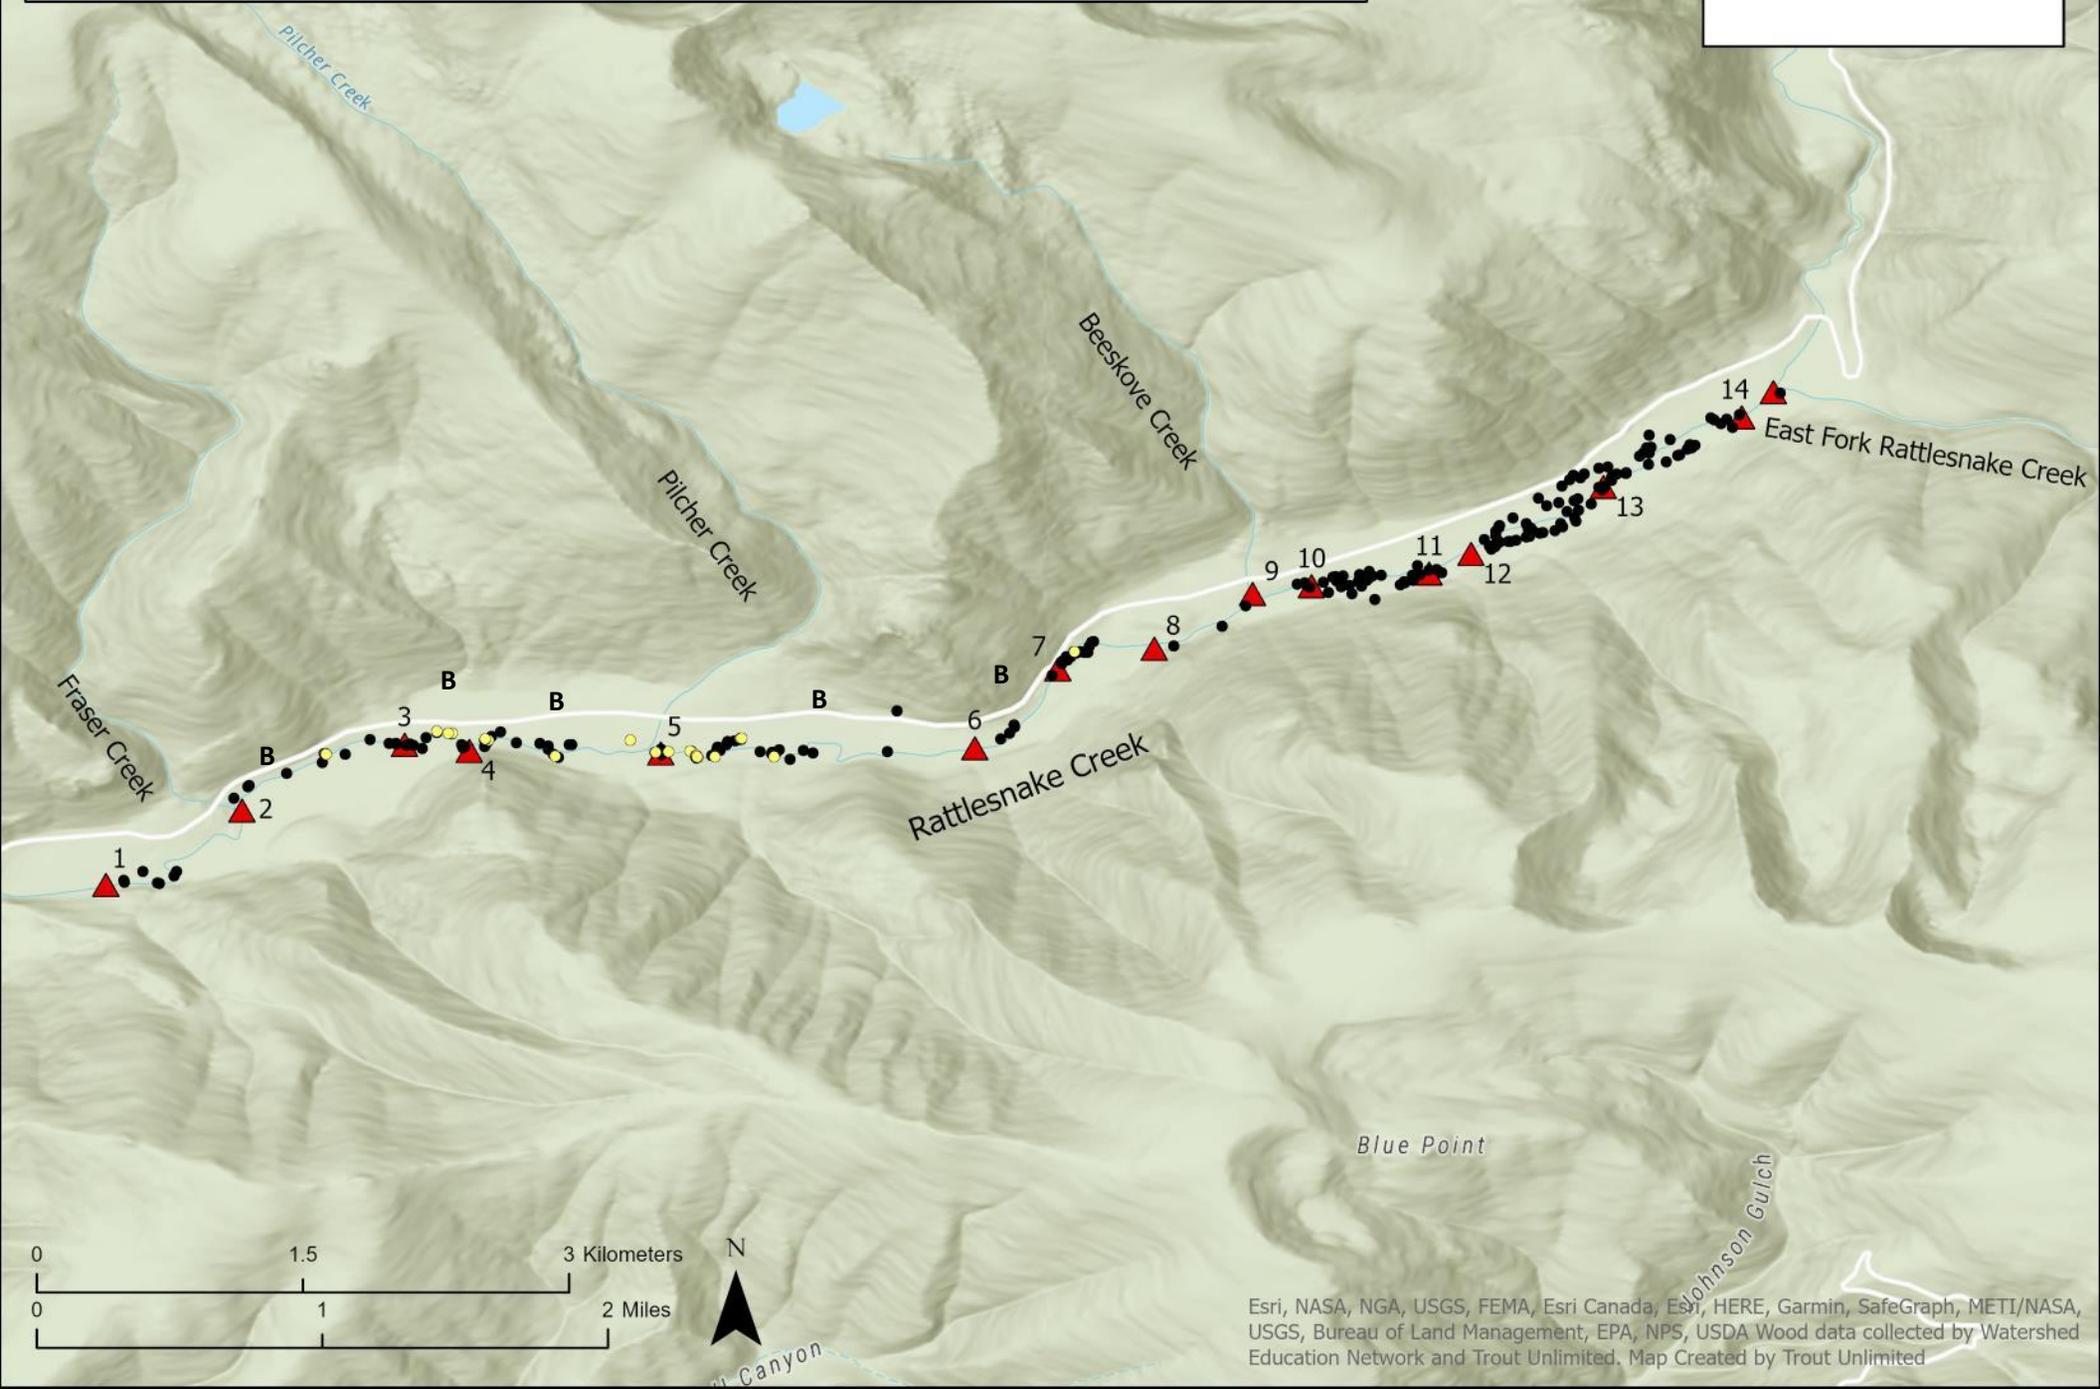
Upper Rattlesnake Creek Instream Wood Survey 2021

- ▲ Reach Boundary
- Beaver Dam
- Large Wood
- B Beaver-influenced area
